**SAG HARBOR  
FORMER MANUFACTURED GAS PLANT SITE**

**REMEDIAL INVESTIGATION REPORT**

**DVIRKA AND BARTILUCCI CONSULTING ENGINEERS  
330 Crossways Park Drive  
Woodbury, New York**

**JUNE 2002**

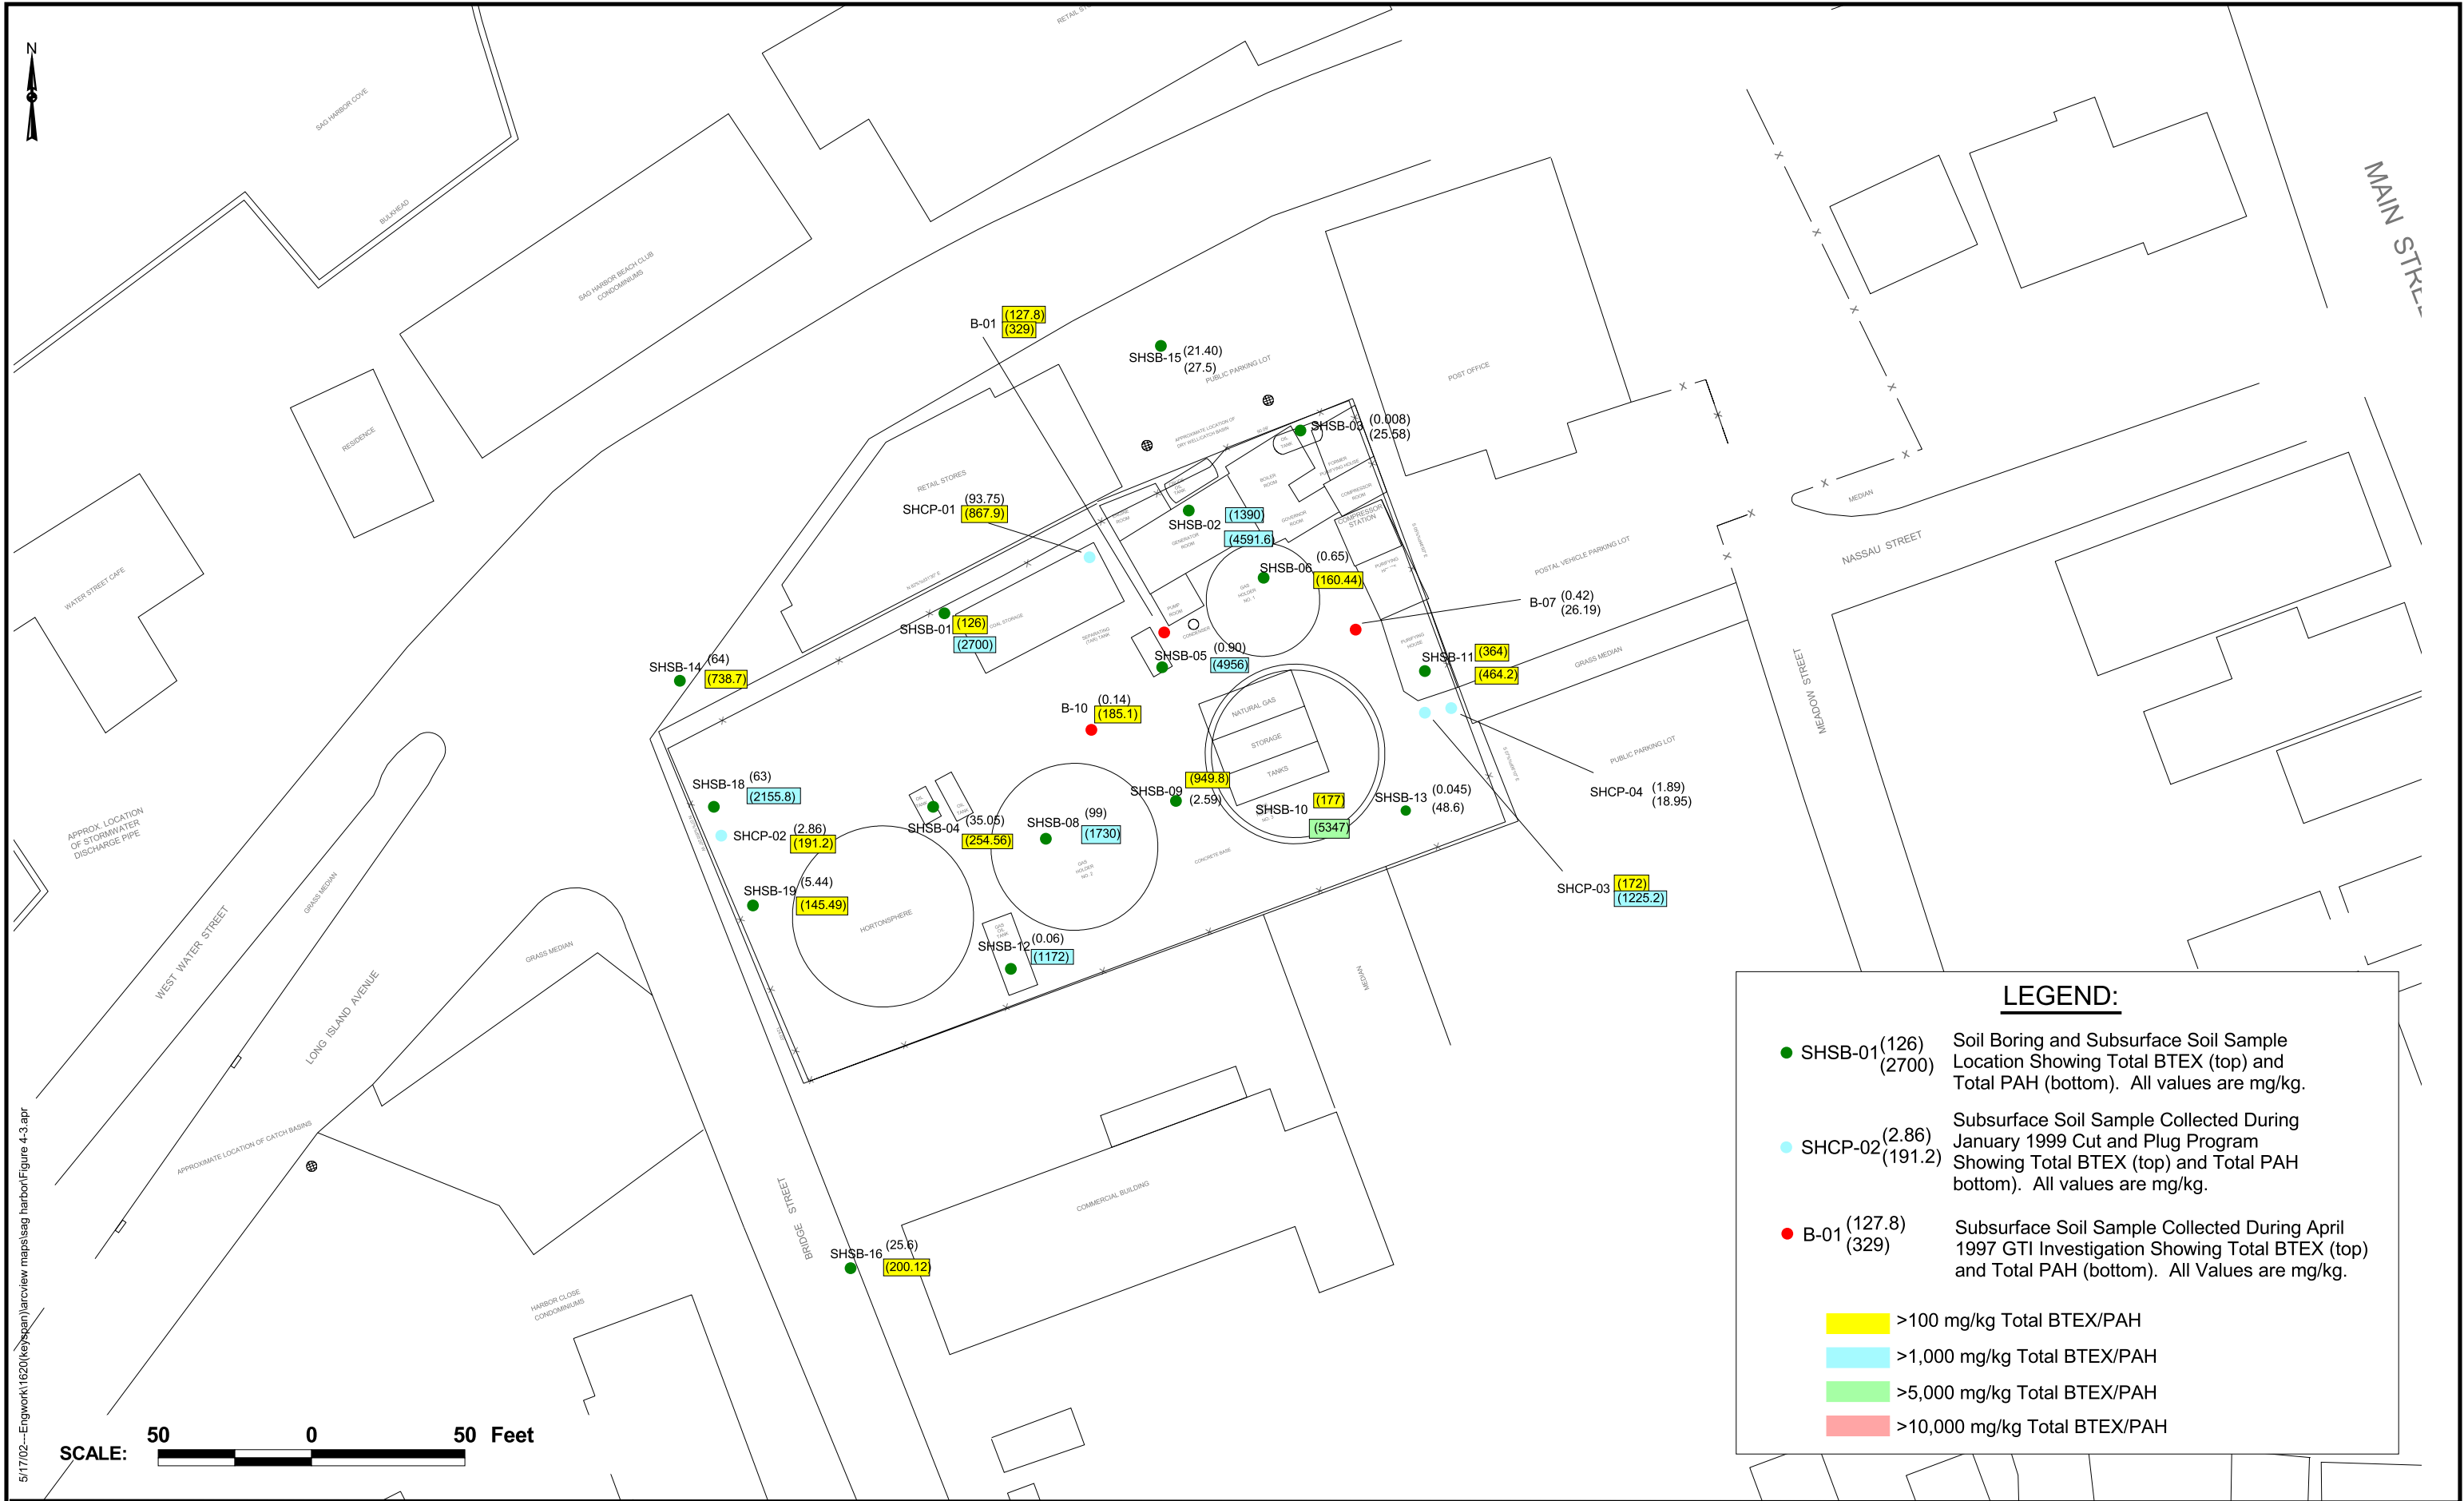
**Figures 4-2 through 4-5** depict total BTEX concentrations along with total PAH concentrations in subsurface soil at on-site and off-site sample locations. The maps include soil data generated as part of this investigation, as well as data generated under the Cut and Plug IRM (see **Section 2.8**) and the 1997 Phase I Site Investigation report (see **Section 1.7**). The data used for **Figure 4-2** is based on subsurface data collected at depths ranging from 0 to 2 feet bgs. The data used for **Figure 4-3** is based on subsurface soil data collected at depths ranging from 2-8 feet bgs. The data used for **Figure 4-4** is based on subsurface soil data collected at depths
