Quarterly Groundwater Monitoring Report
First Quarter (Q1) 2018

Sag Harbor Former MGP Site

Village of Sag Harbor
Suffolk County, Long Island, NY
Site ID No. 1-52-159

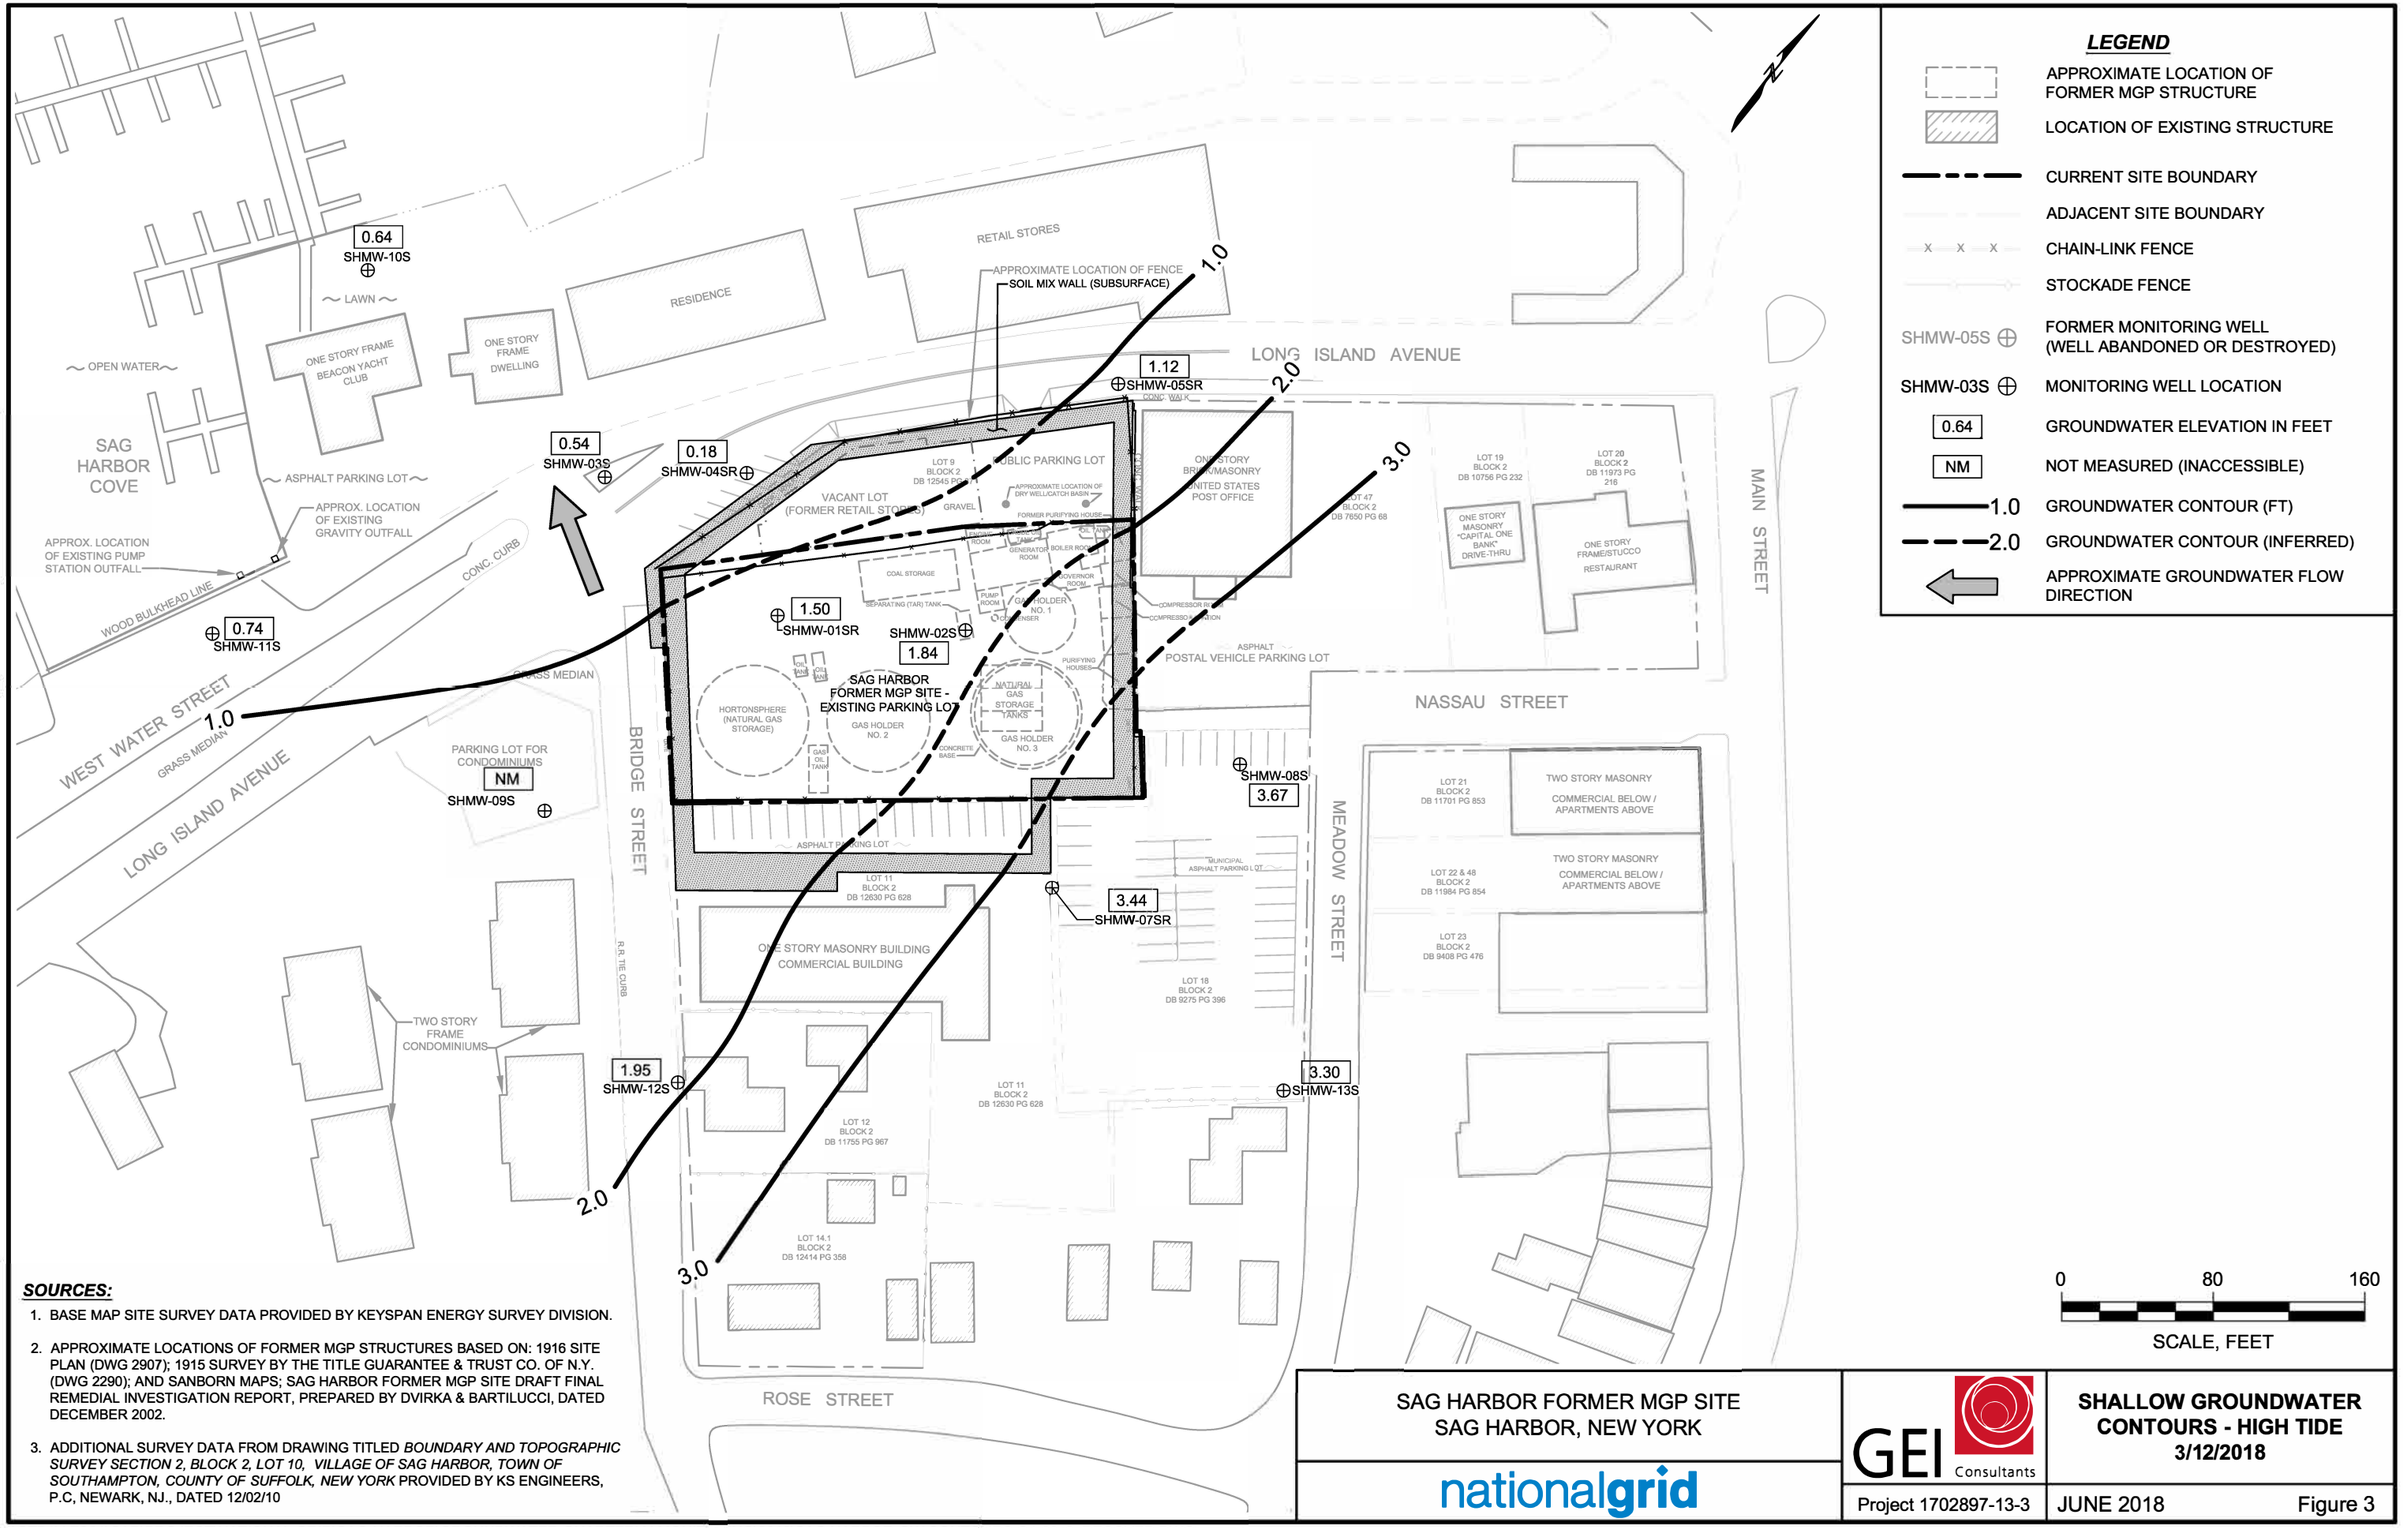
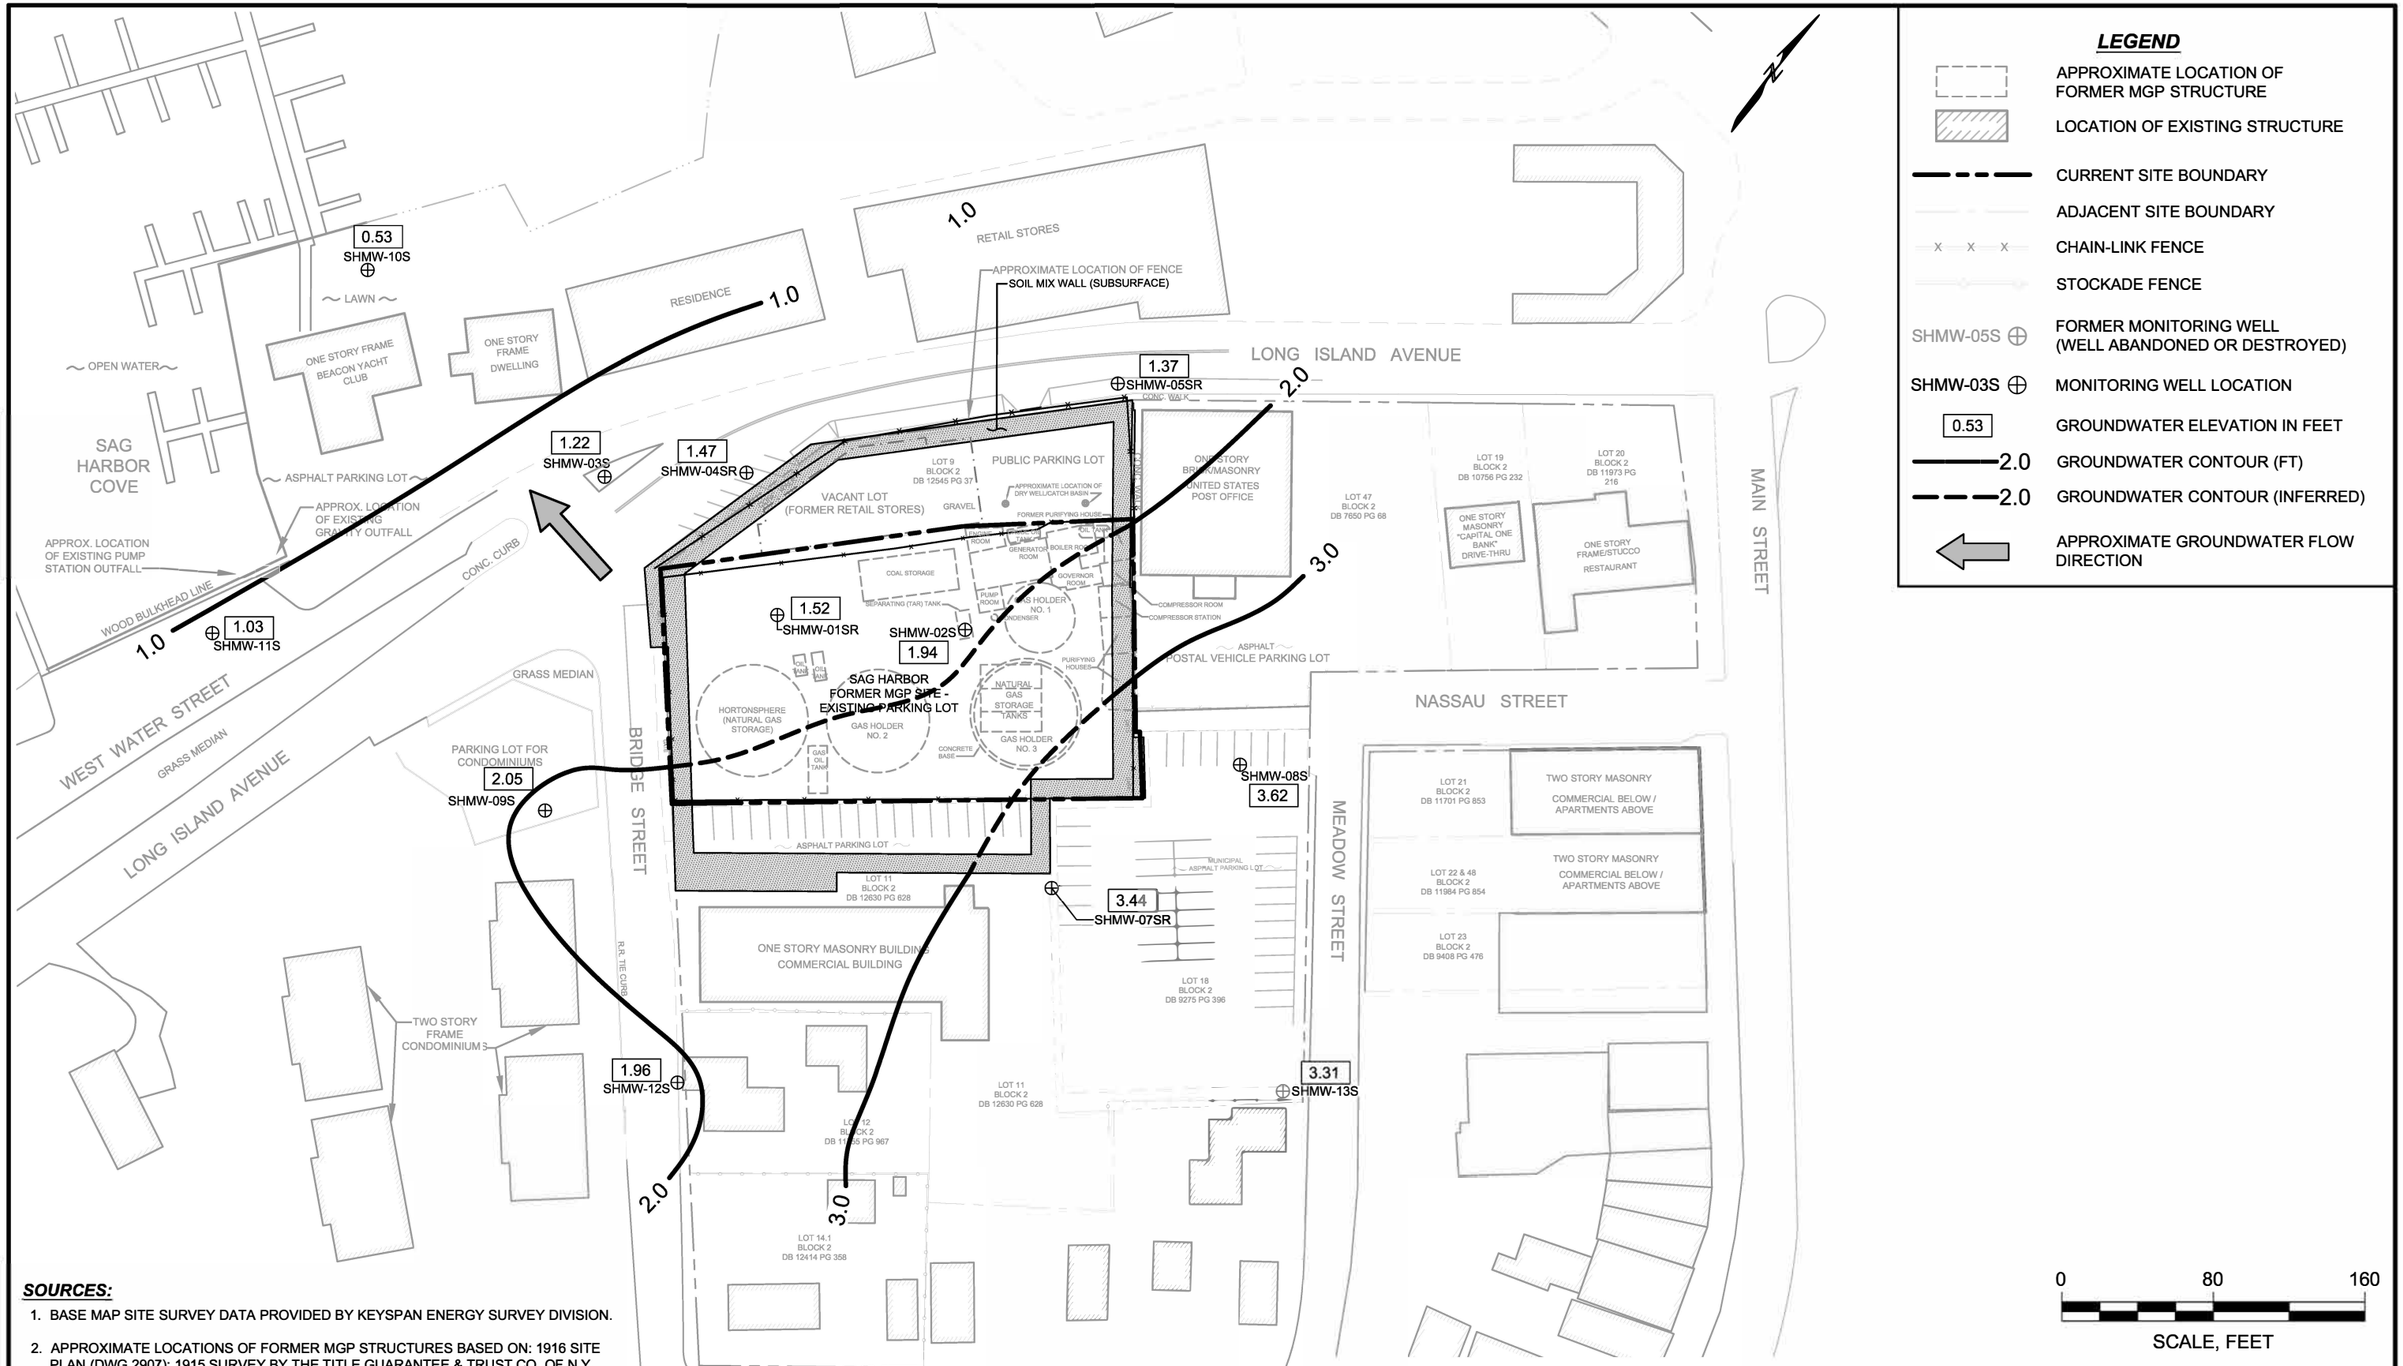
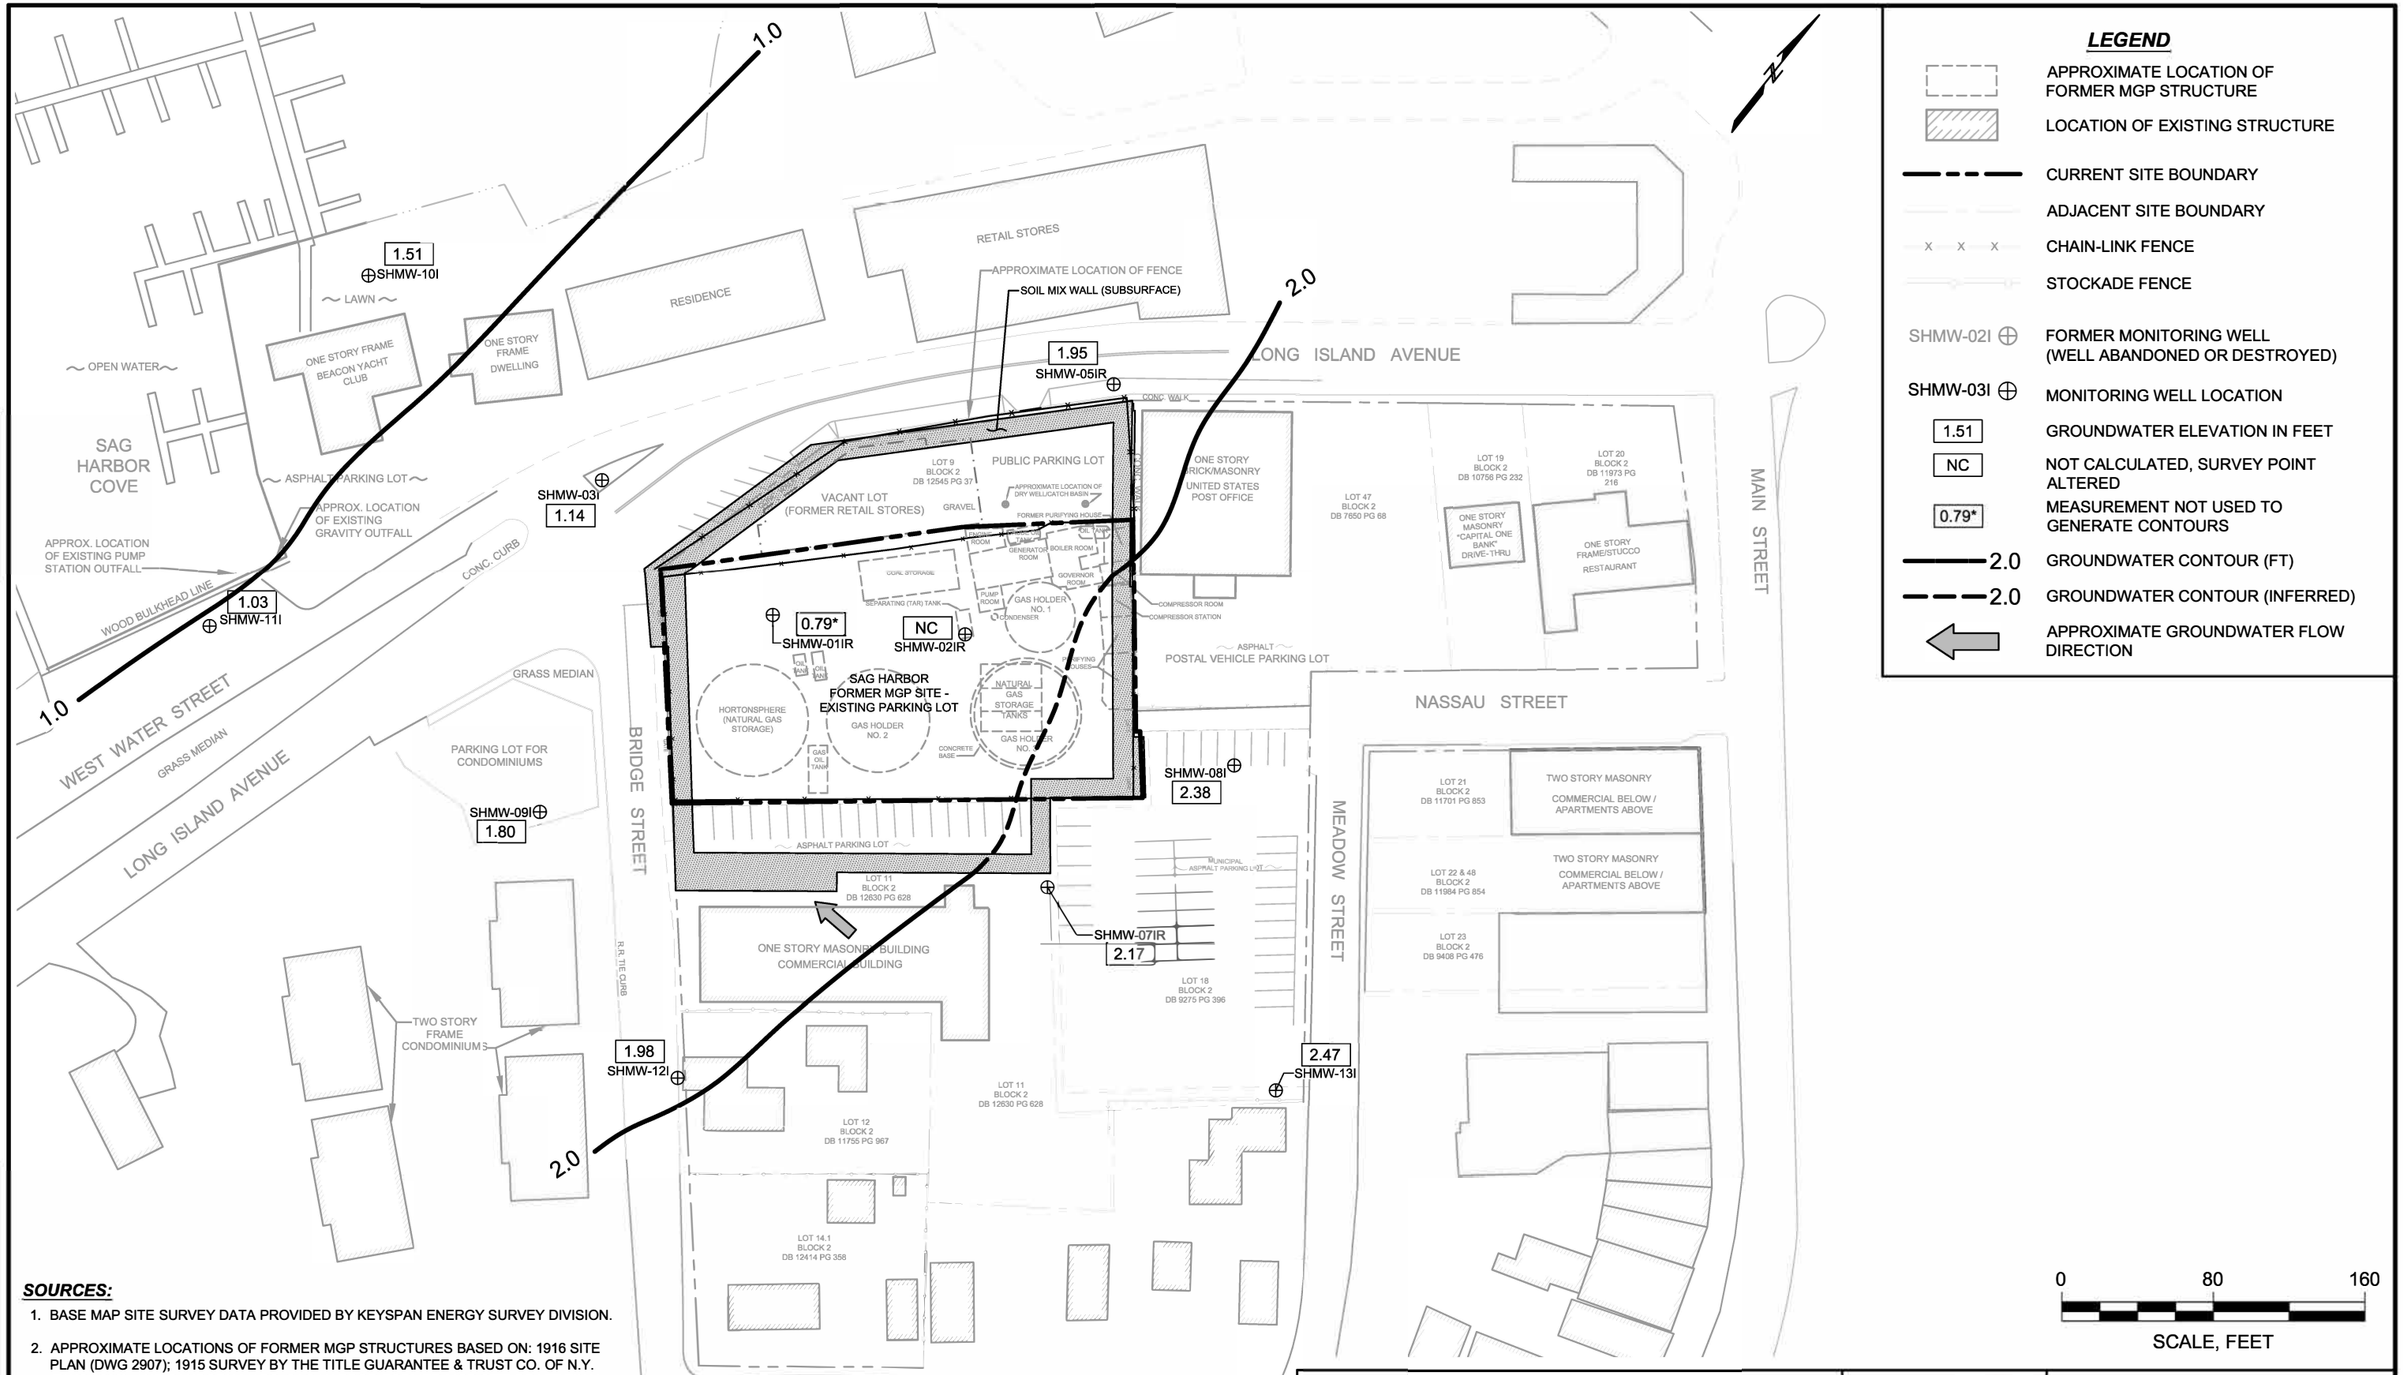
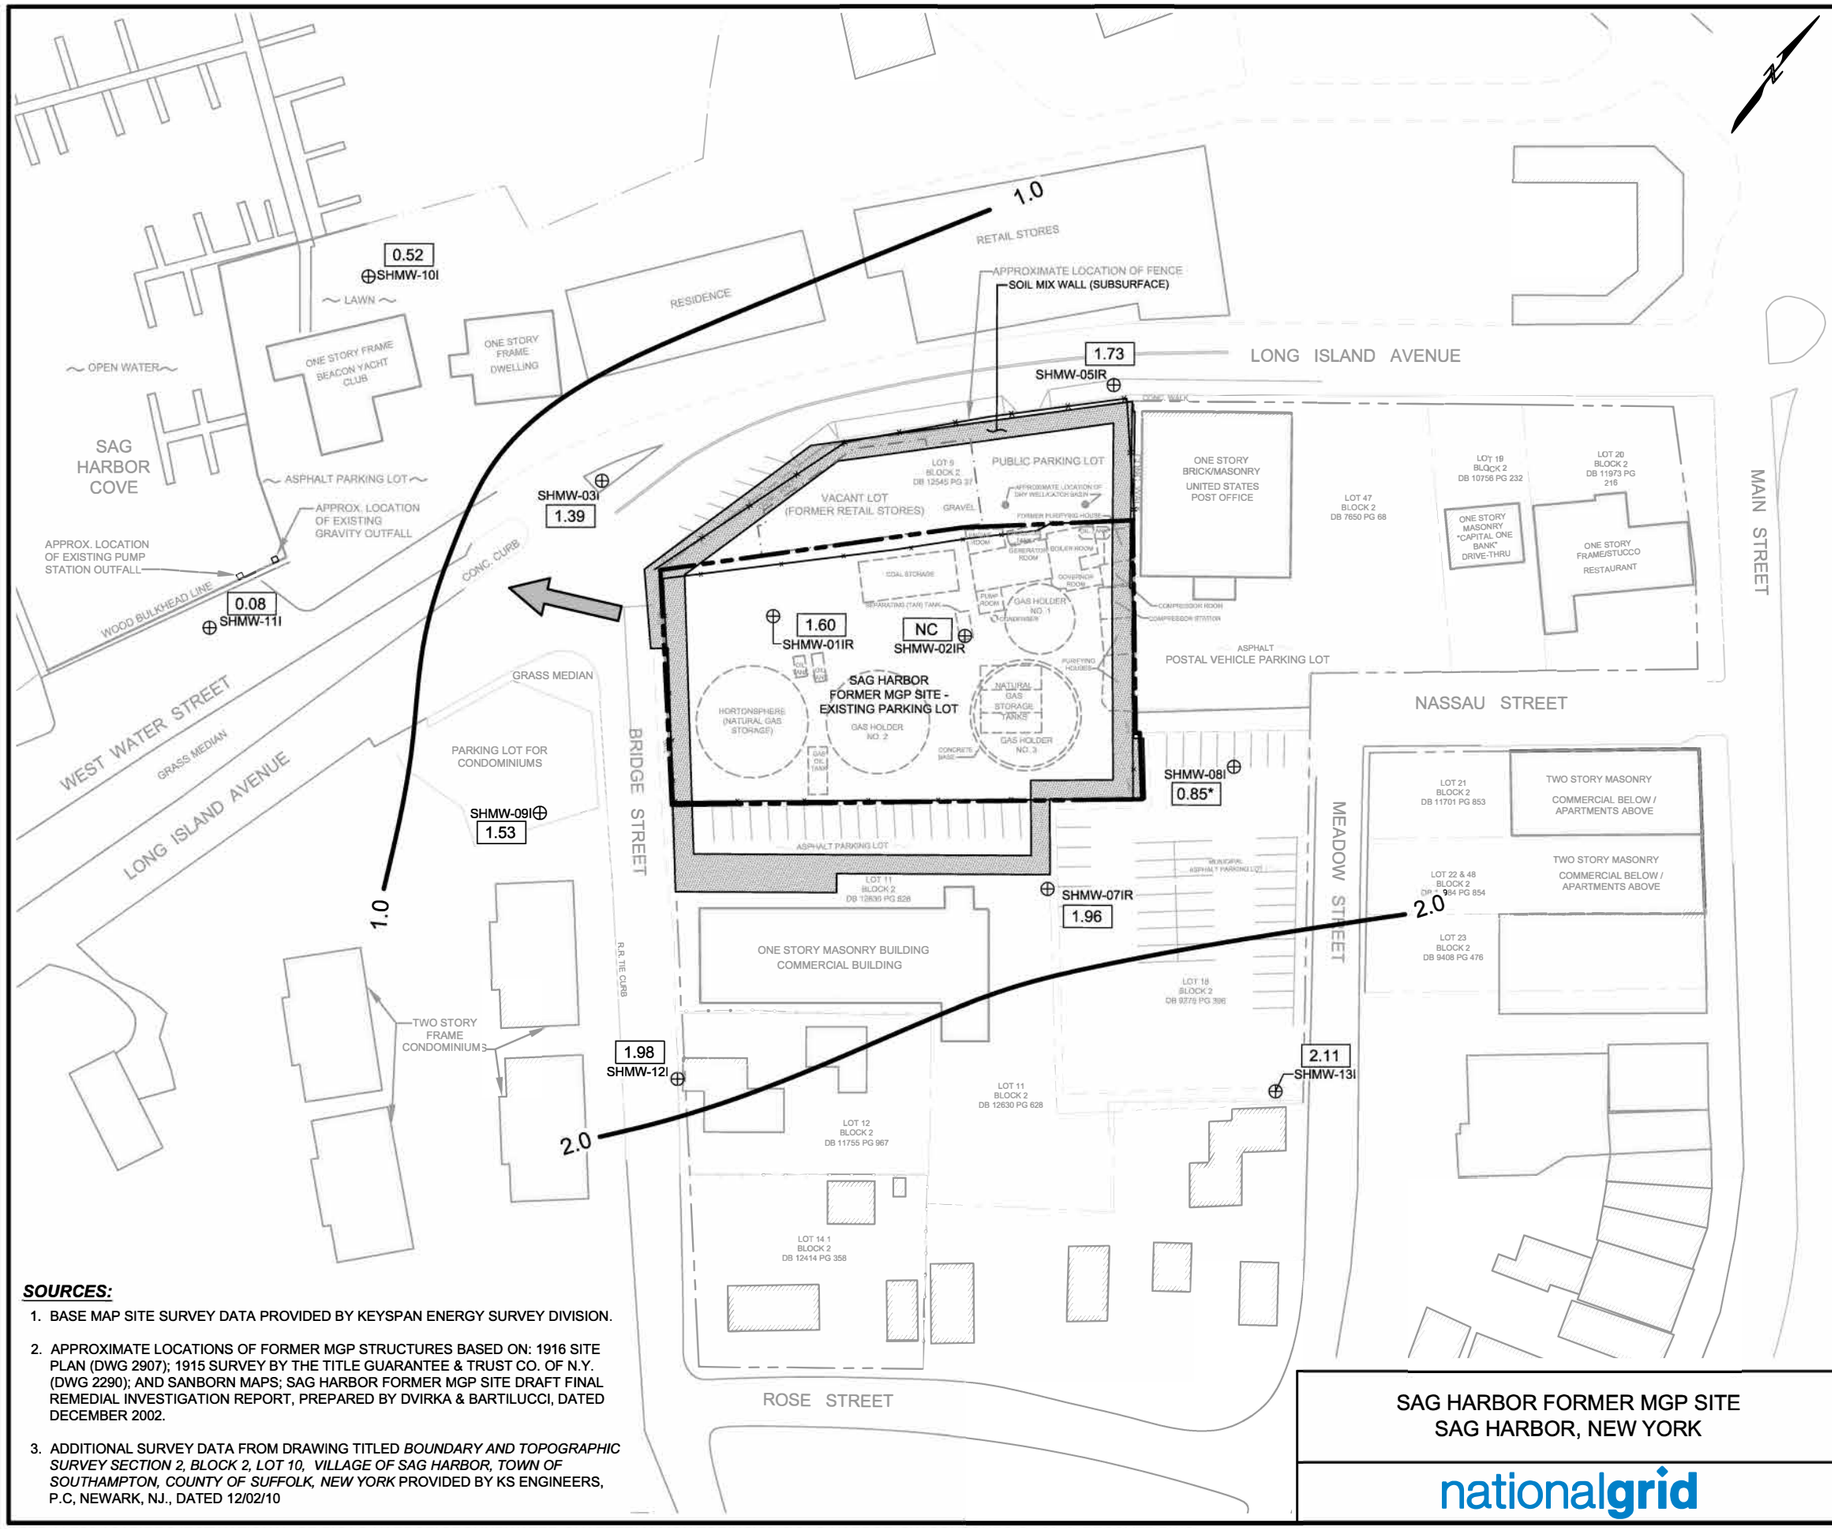
Groundwater levels were measured on March 12, 2018 at all 25 monitoring wells during low tide. One well was inaccessible during high tide. Monitoring well SHMW-02IR was repaired during third quarter (Q3) 2011, altering the survey point. As a result, the groundwater level measurement was not calculated. Depth to groundwater measurements and calculated groundwater elevations are provided in **Table 1**. Shallow and intermediate groundwater contours for high and low tidal conditions are depicted on **Figures 3** through **6**.

The groundwater flow direction was generally to the west towards Sag Harbor Cove. The ranges in depth to water and water table elevation data, as well as calculated hydraulic gradients for the shallow and intermediate portions of the aquifer in Q1 2018, are provided in the following table:
