Second Annual Periodic Review Report (PRR2) June 23, 2017 – June 23, 2018

Sag Harbor Former MGP Site

Village of Sag Harbor Suffolk County, Long Island, NY Site ID No. 1-52-159

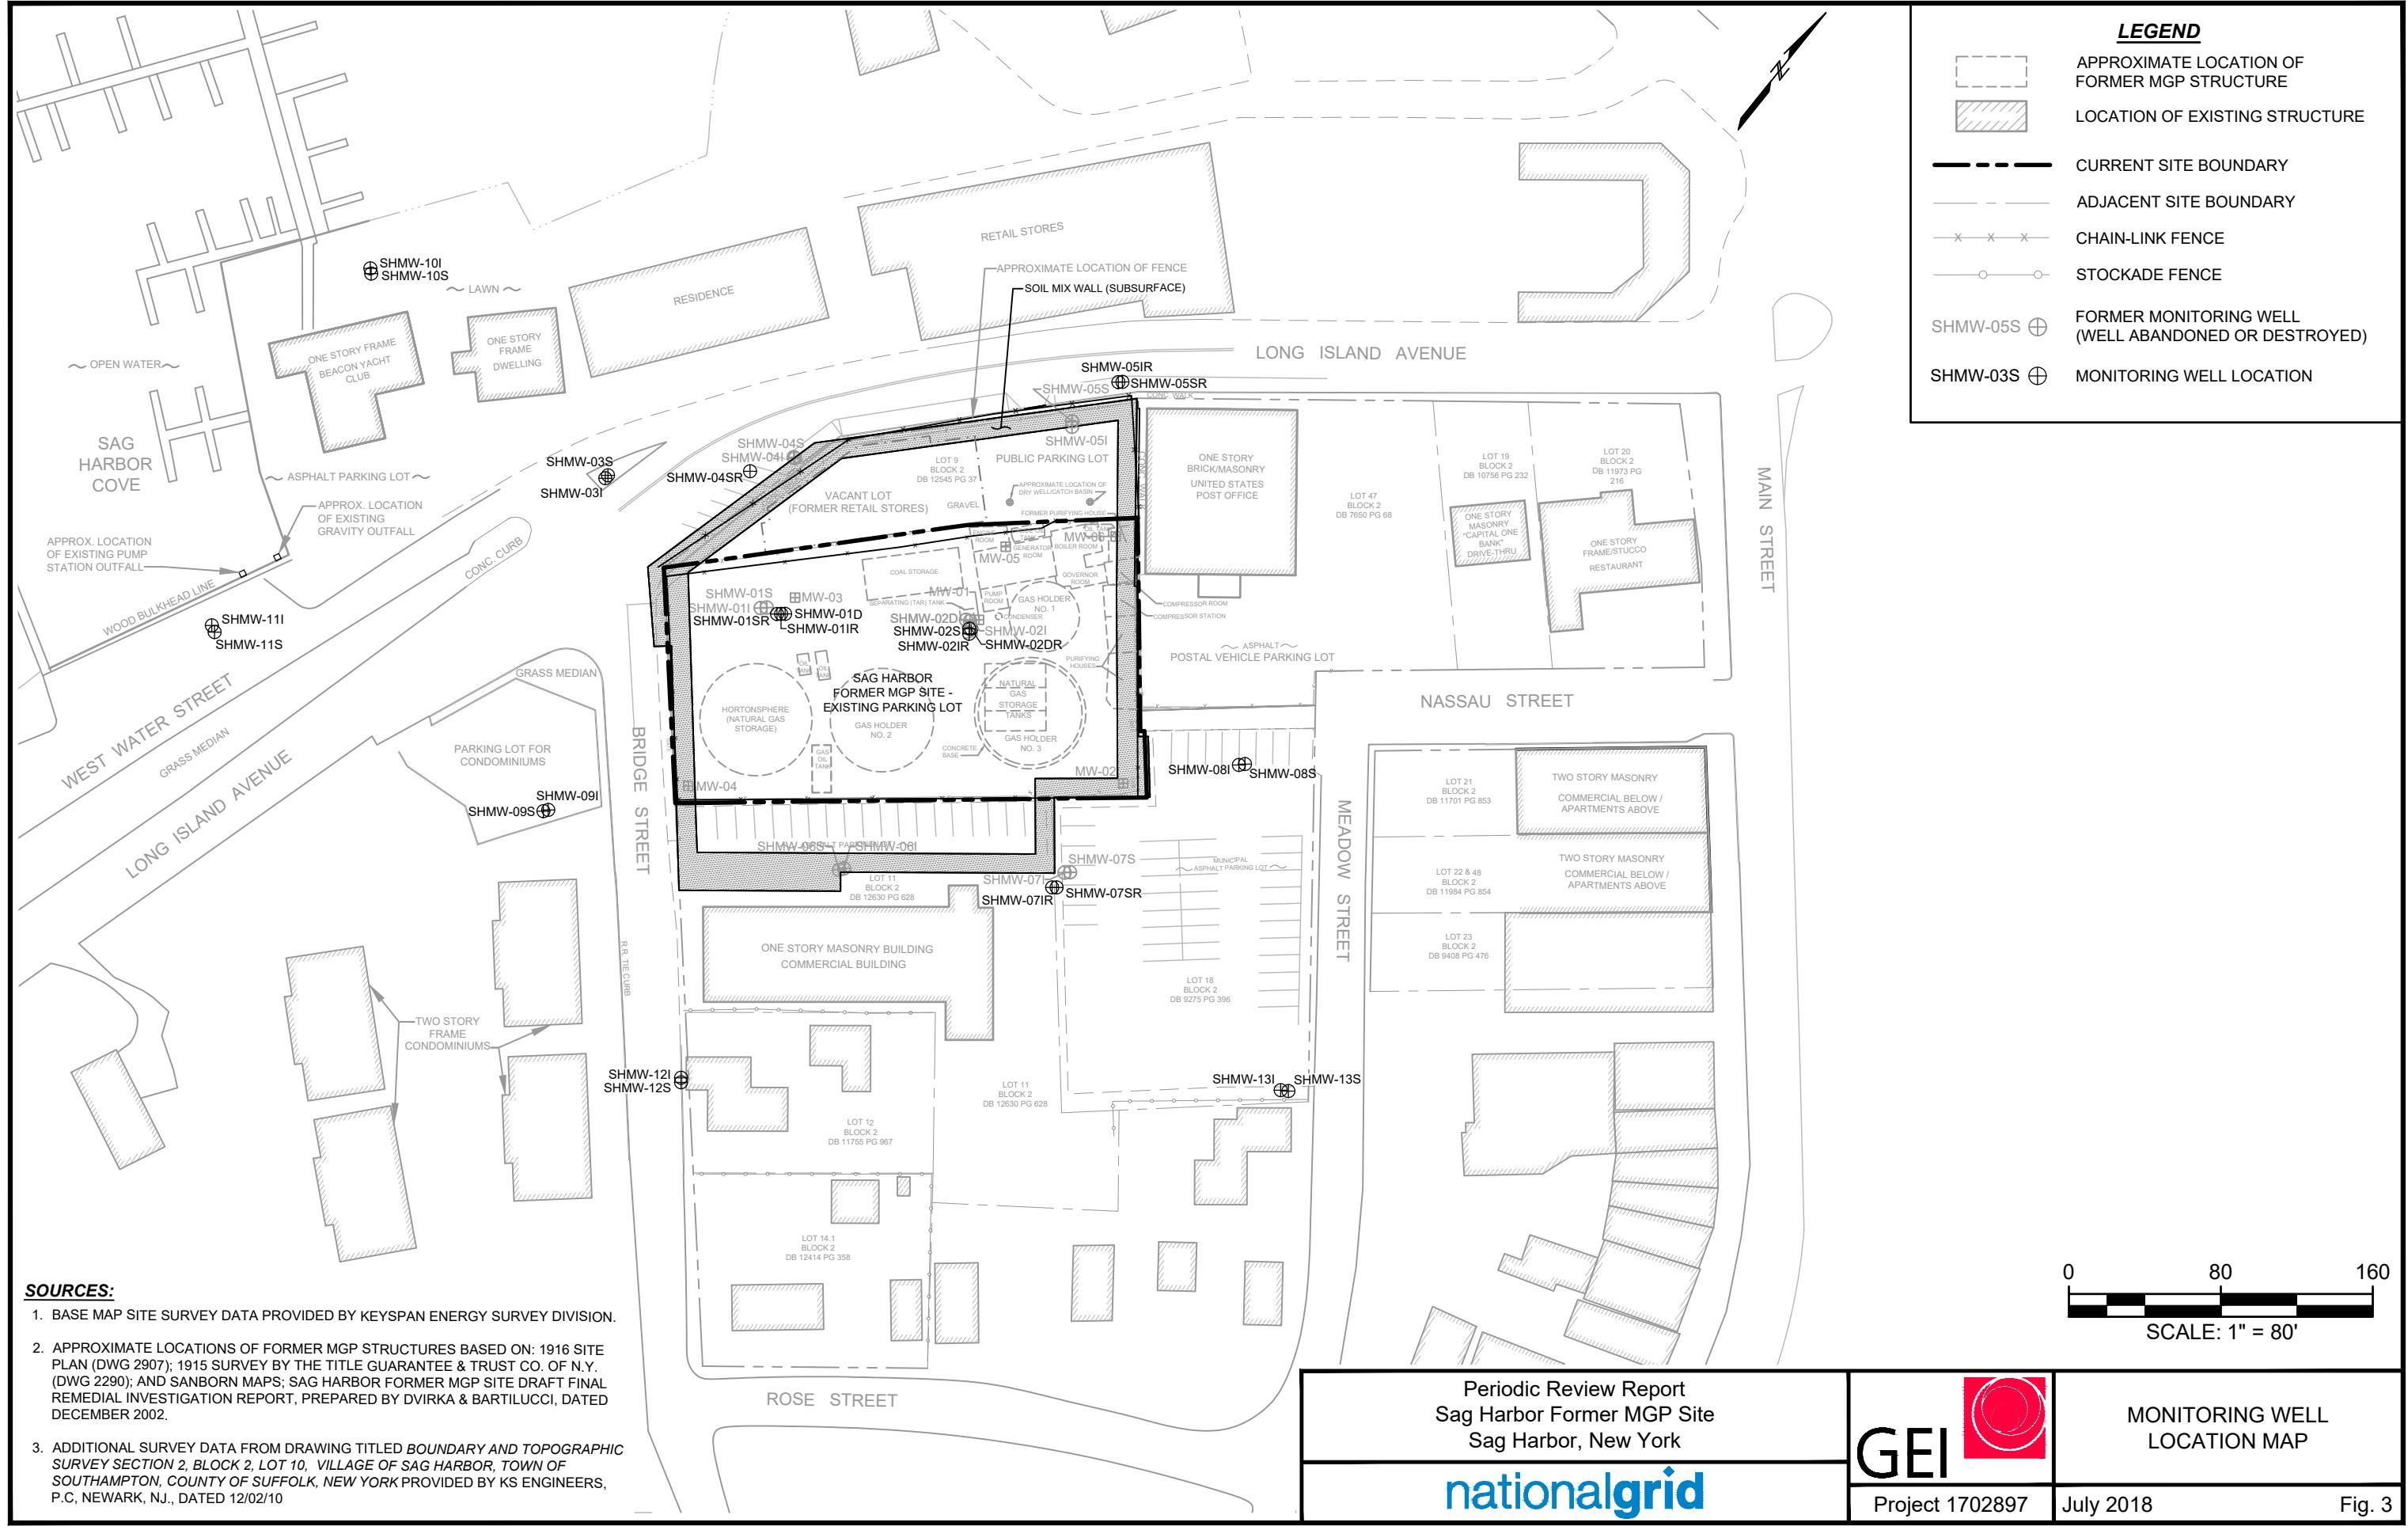
A total of 25 monitoring wells are currently located at or in the vicinity of the Site (**Figure 3**). This network was initially designed to monitor both up-gradient and down-gradient conditions at the Site and off-Site areas.

Four monitoring well clusters (SHMW-7SR/SHMW-7IR; SHMW-8S/SHMW-8I; SHMW-12S/ SHMW- 12I; and SHMW-13S/SHMW-13I), each consisting of one shallow aquifer well and one intermediate aquifer well, were installed in the shallow and intermediate overburden groundwater aquifer to determine the upgradient groundwater conditions.

One monitoring well cluster (SHMW-9S/SHMW-9I) consisting of one shallow aquifer well and one intermediate aquifer well was installed in the shallow and intermediate overburden groundwater aquifer to determine the side-gradient groundwater conditions.

Four monitoring well clusters (SHMW-3S/SHMW-3I; SHMW-5SR/SHMW-5IR; SHMW-10S/ SHMW-10I; and SHMW-11S/SHMW-11I), each consisting of one shallow aquifer well and one intermediate aquifer well, were installed in the shallow and intermediate overburden groundwater aquifer and monitoring well SHMW-4SR was installed in the shallow overburden aquifer to determine downgradient groundwater conditions.

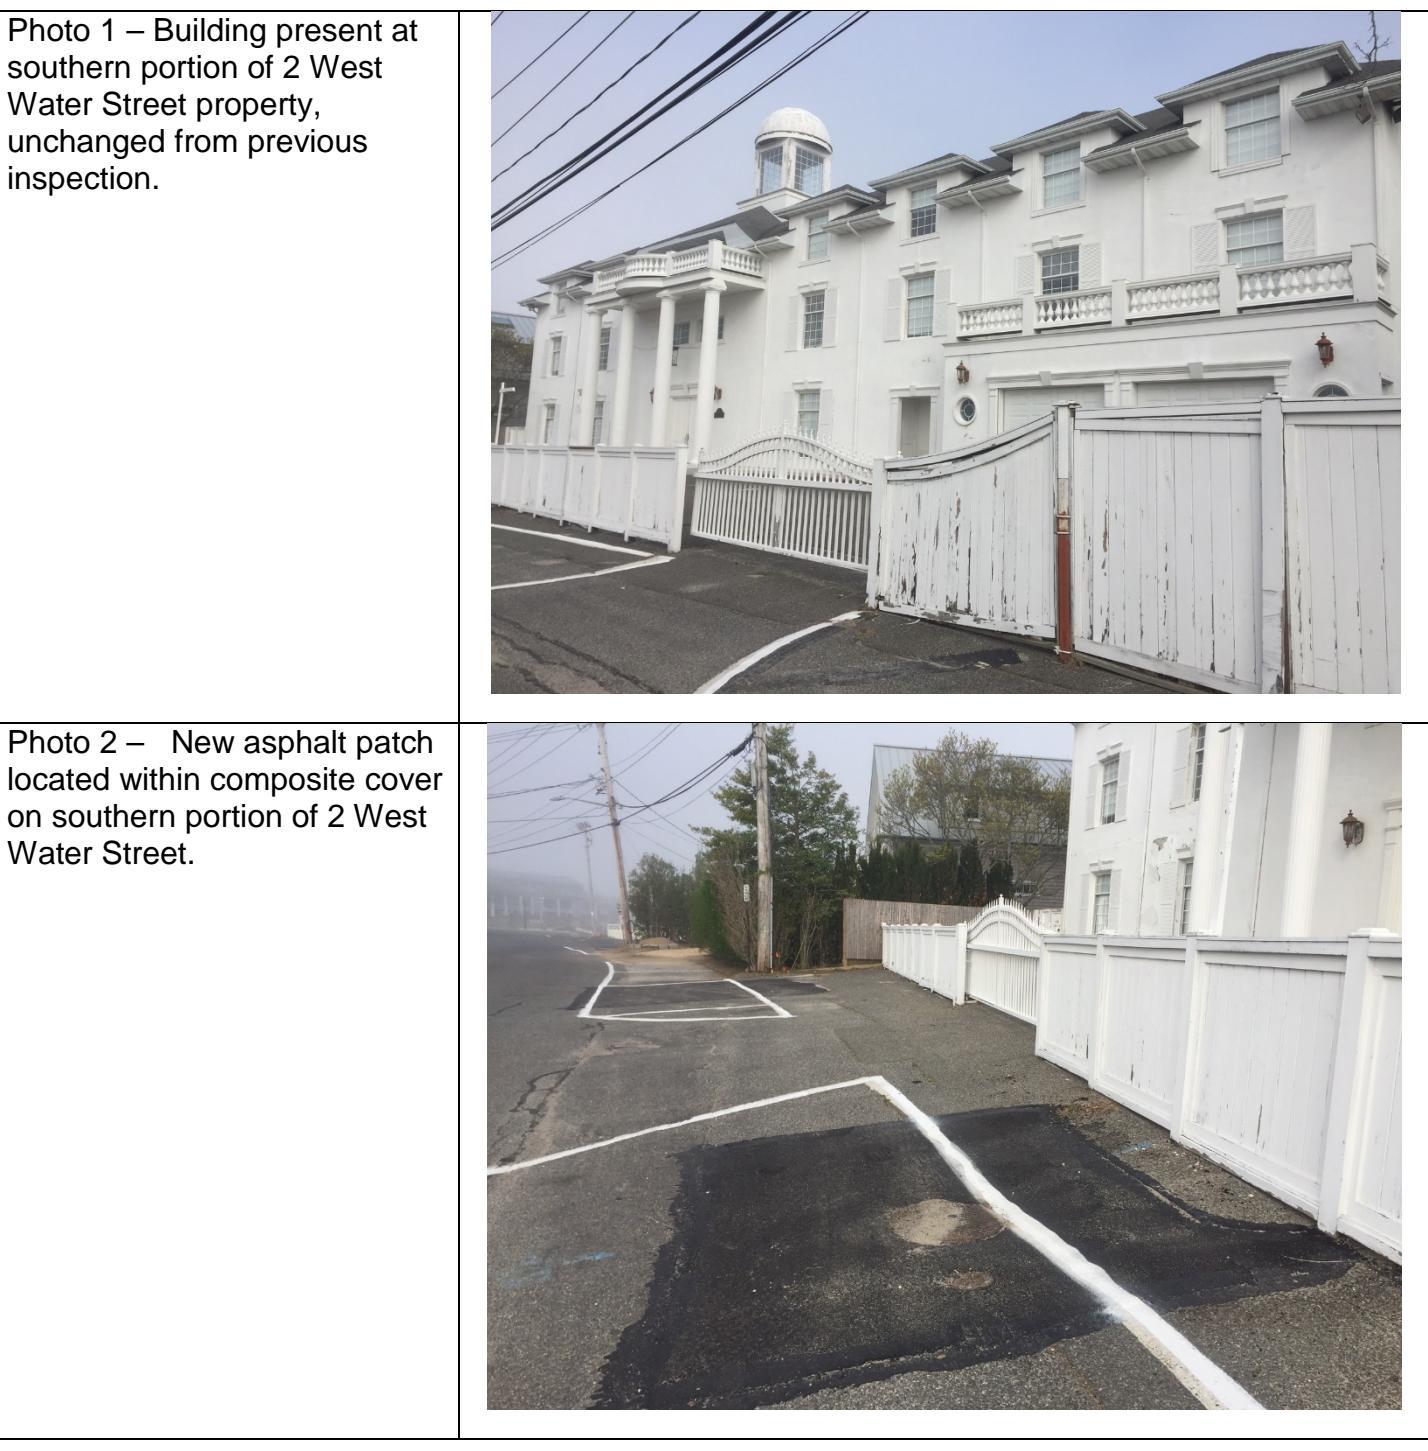
Photo 1 – Building present at southern portion of 2 West Water Street property, unchanged from previous inspection.

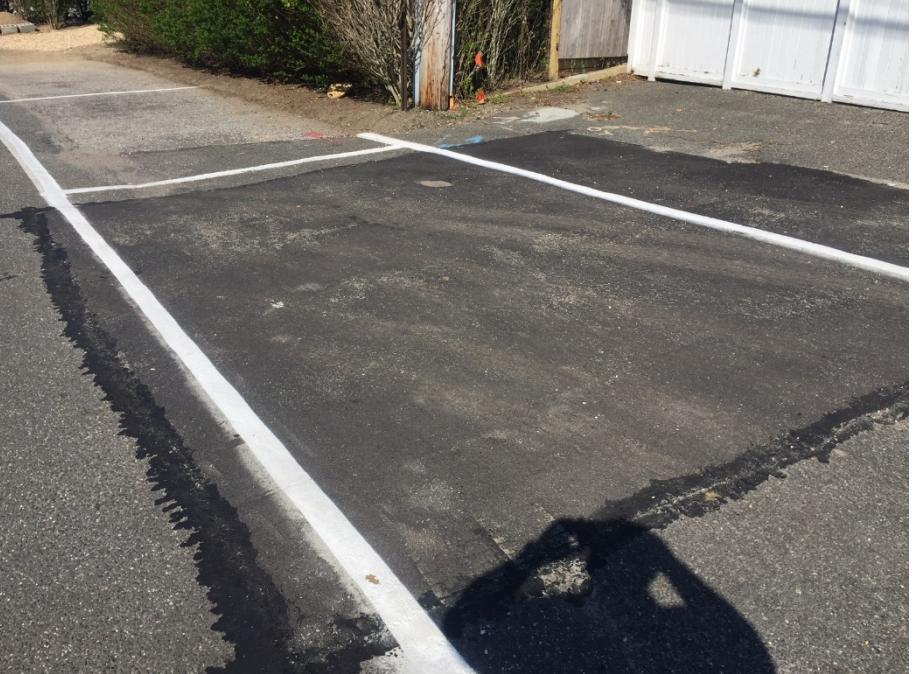
Photo 3 – Other new asphalt patch within composite cover located next to the building.

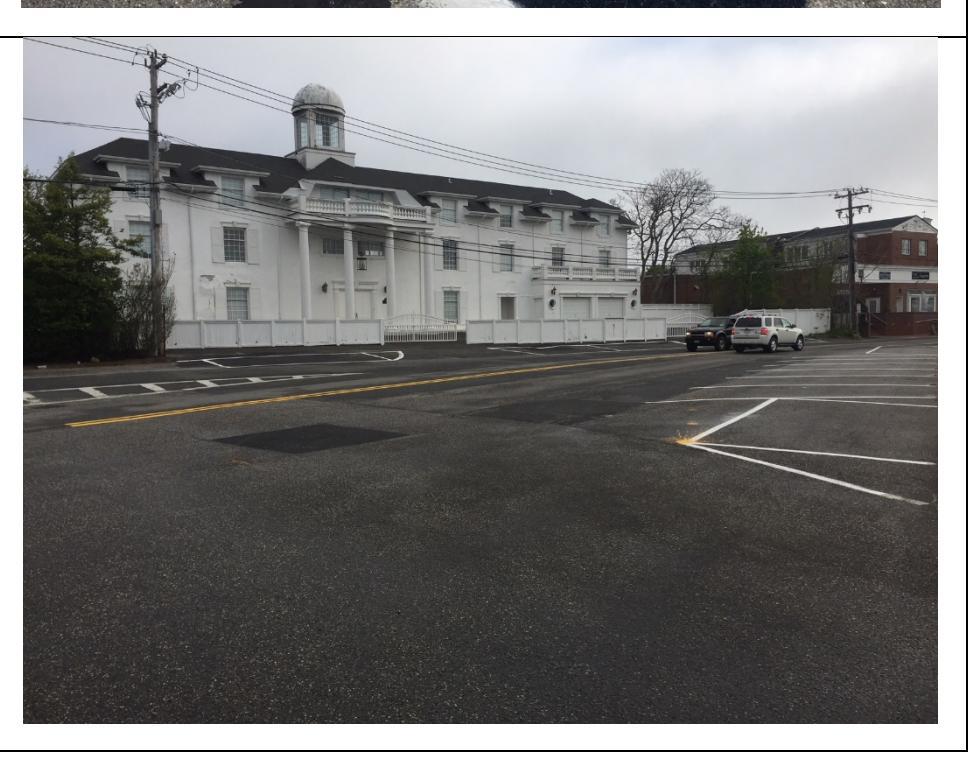
Photo 4 – Property and composite cover at southern portion of 2 West Water Street from a distance.

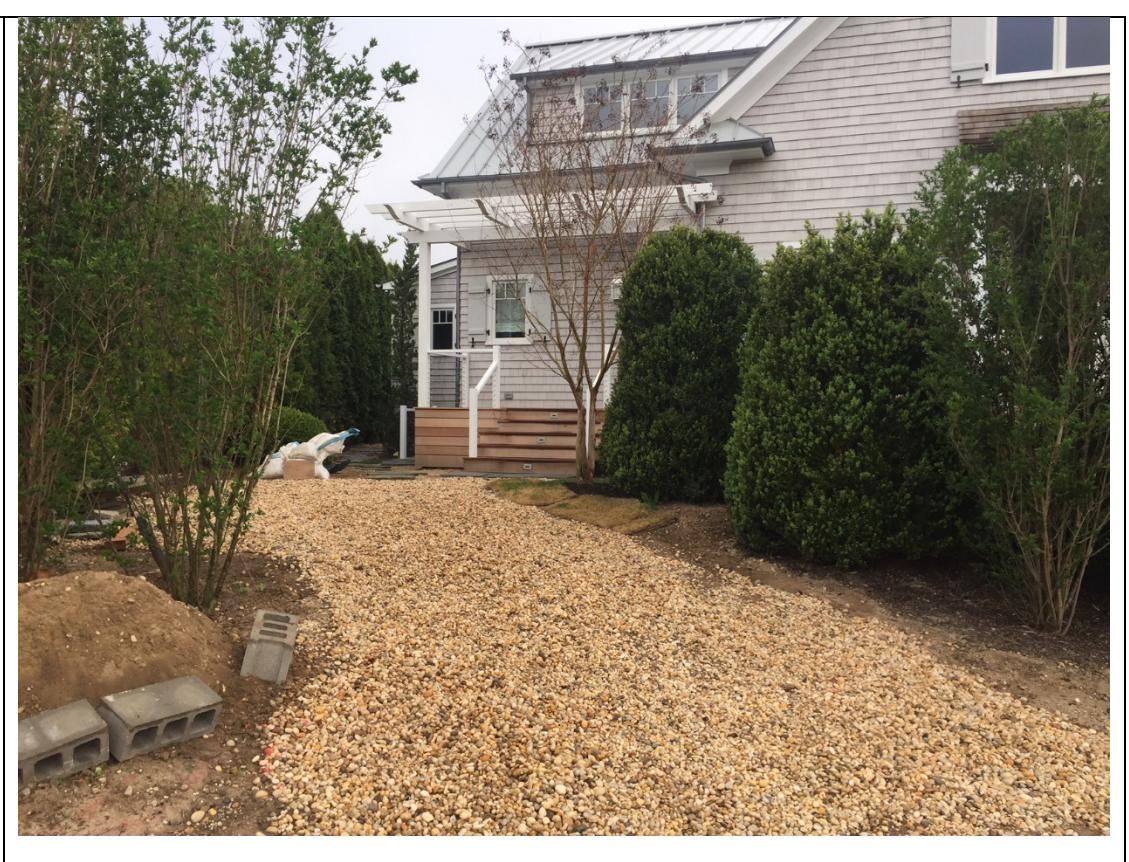
Photo 1 – Composite cover on the southern portion of 4 West Water Street. Renovations to the building, and new gravel driveway and grass patches noted.

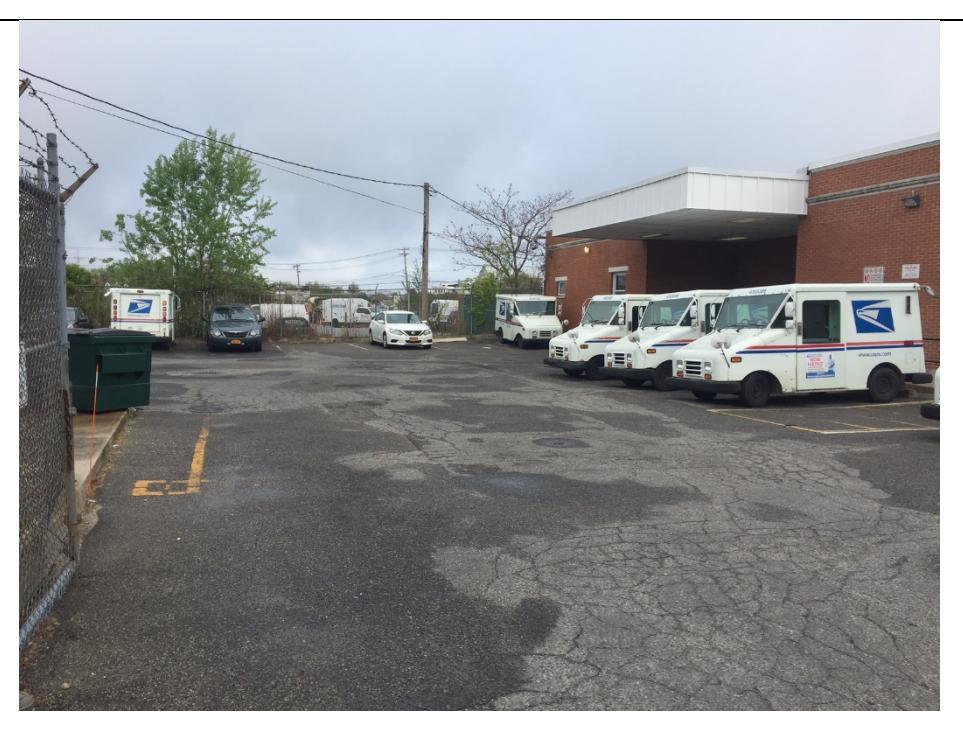
Photo 3 – Composite cover and rear of the USPS building on the southern portion of the property. No changes to the building from the previous inspection observed.

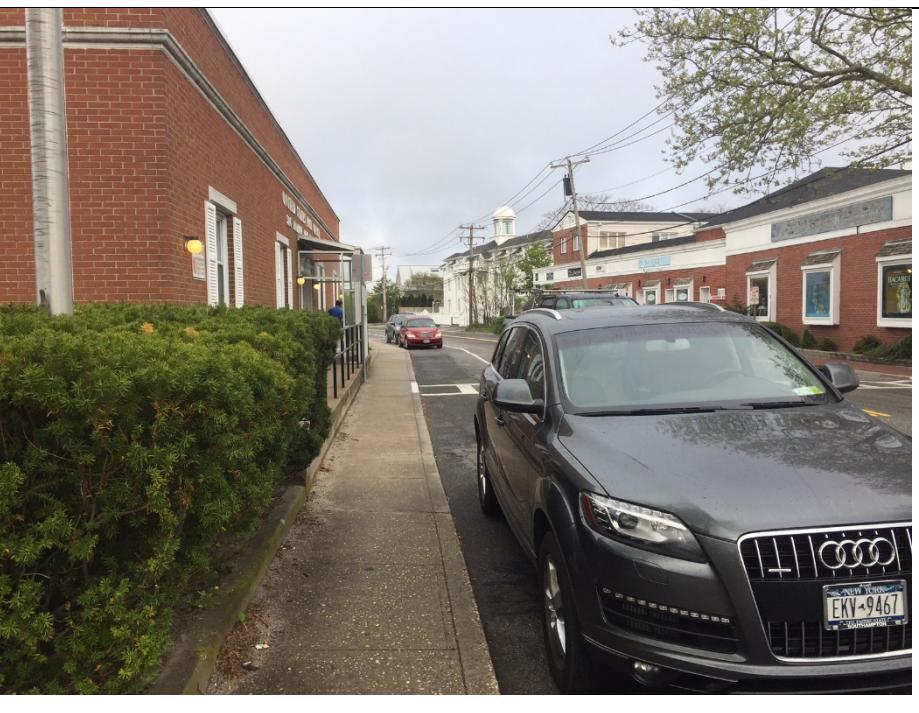
Photo 4 – Composite cover and front of the USPS building on the northern portion of the property on Long Island Avenue.
